STRUCTURAL STABILITY ASSESSMENT REPORT

Economizer Ash System, Big Bend Power Plant
Apollo Beach, Florida

PREPARED FOR:
Tamp Electric Company

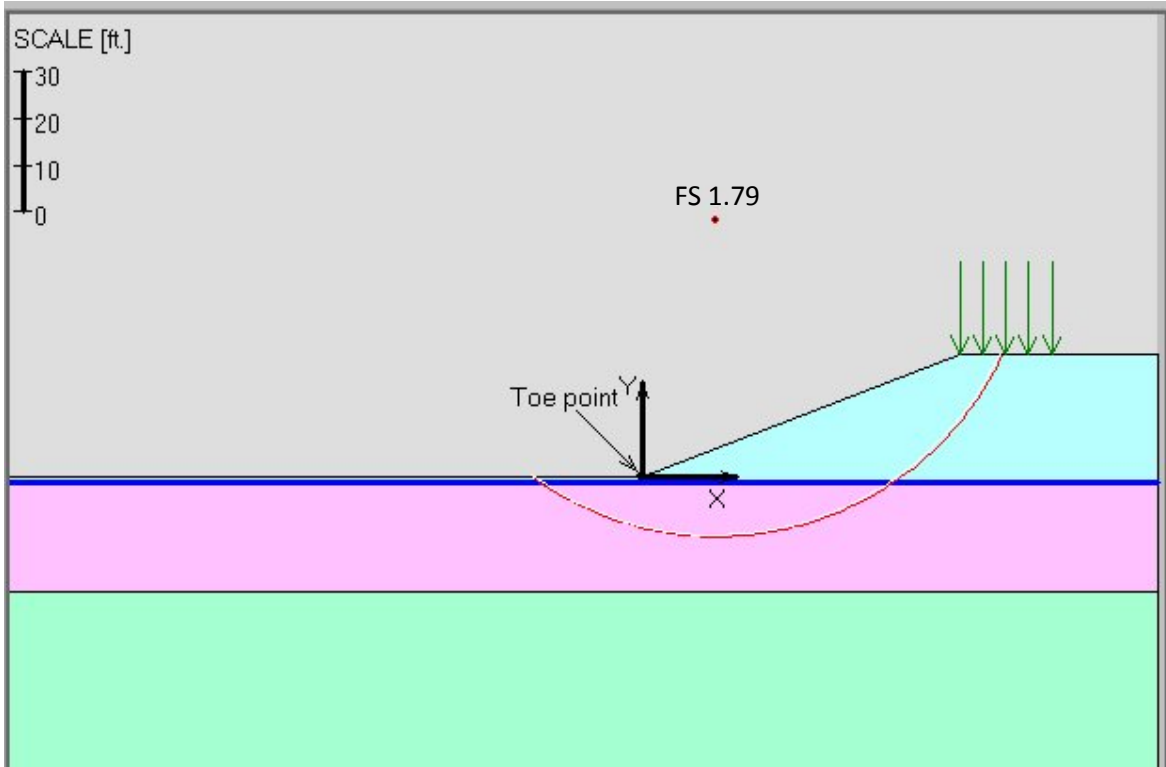
Location: EAP – 3
Condition: Maximum Pool Storage

Location ID	Location	Required Factor of Safety		Calculated Factor of Safety	
		Maximum Pool Storage	Maximum Pool Surcharge	Maximum Pool Storage	Maximum Pool Surcharge
EAP-3	North Slope North Economizer Ash Pond	≥ 1.5	≥ 1.4	1.79	1.41
EAP-7	East Slope North Economizer Ash Pond			1.76	1.4
EAP-8	East Slope South Economizer Ash Pond			1.53	1.41
EAP-11	South Slope South Economizer Ash Pond			1.76	1.41
EAP-15	West Slope Economizer Suction Ash Pond			1.79	1.41
