Subject: **Annual (2016) Earthen Berm Inspection Report**
East Stormwater Pond, North Recycle Pond, South Recycle Pond,
SSU & Settling Pond, Long Term Fly Ash Pond, North Bottom Ash Pond,
Bottom Ash Suction Pond, South Bottom Ash Pond, Long Term Bottom Ash Pond
Tampa Electric Company
Big Bend Power Station
Apollo Beach, FL
AREHNA Project No. B-15-073

Earthen Berm Inspection
TECO Big Bend, FL
AREHNA Project No. B-15-073

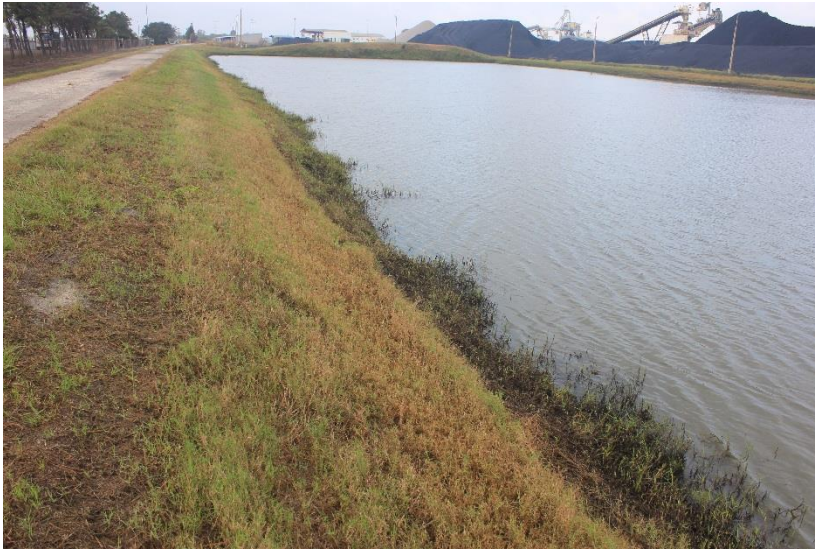
East Stormwater Pond
(south side, looking west)

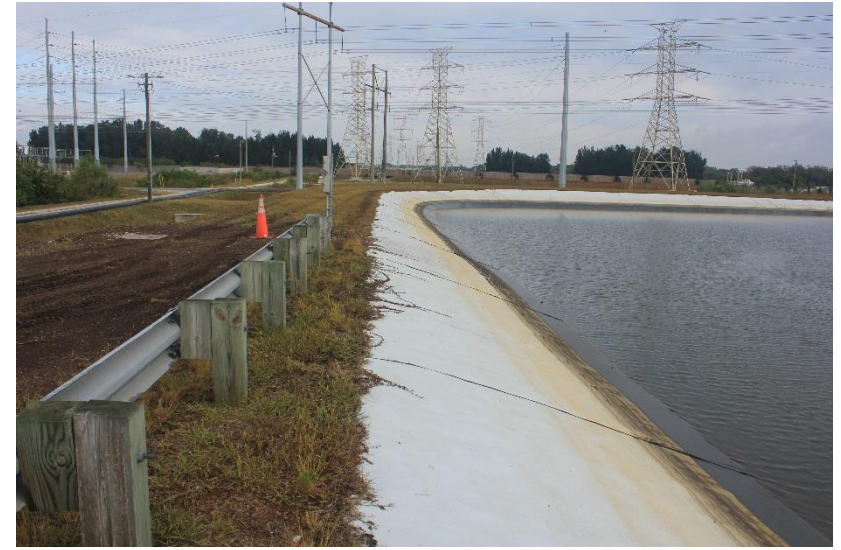
North Recycle Pond
(west side, looking northeast)

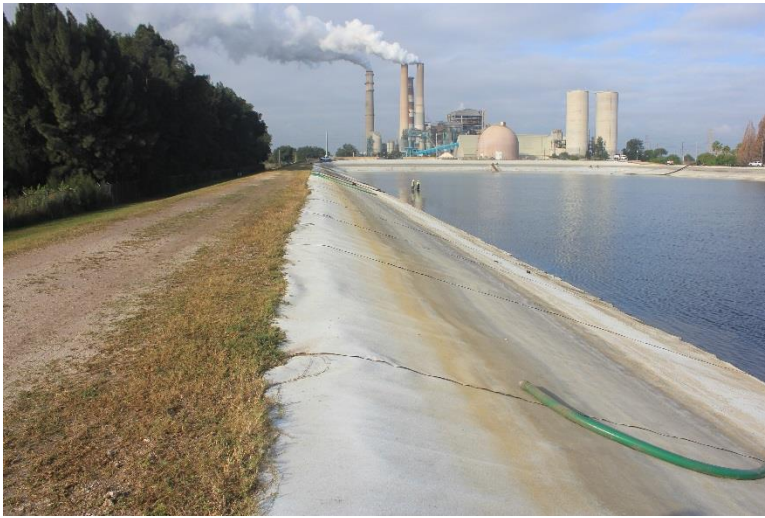
South Recycle Pond
(south side, looking west)

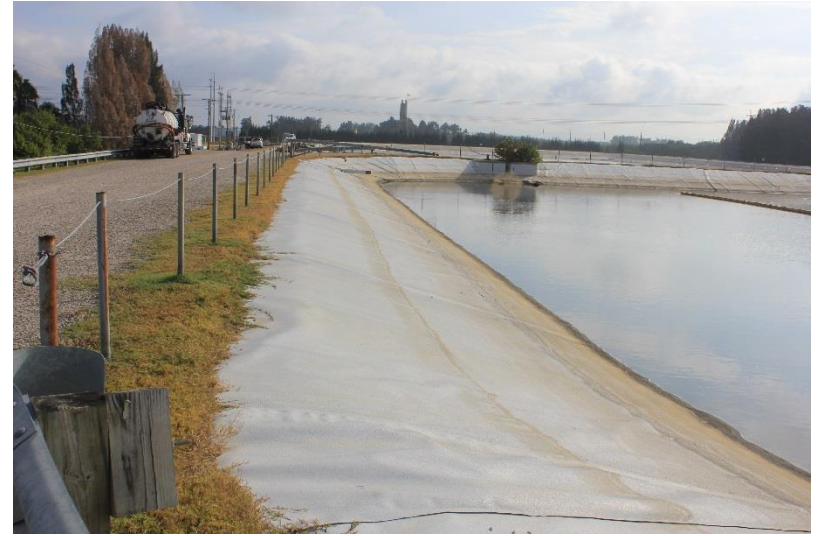
Recycle Settling Pond – The repairs that were underway at the time of our last annual inspection were completed and the pond is back online.

Recycle Settling Pond
(north side, looking east)

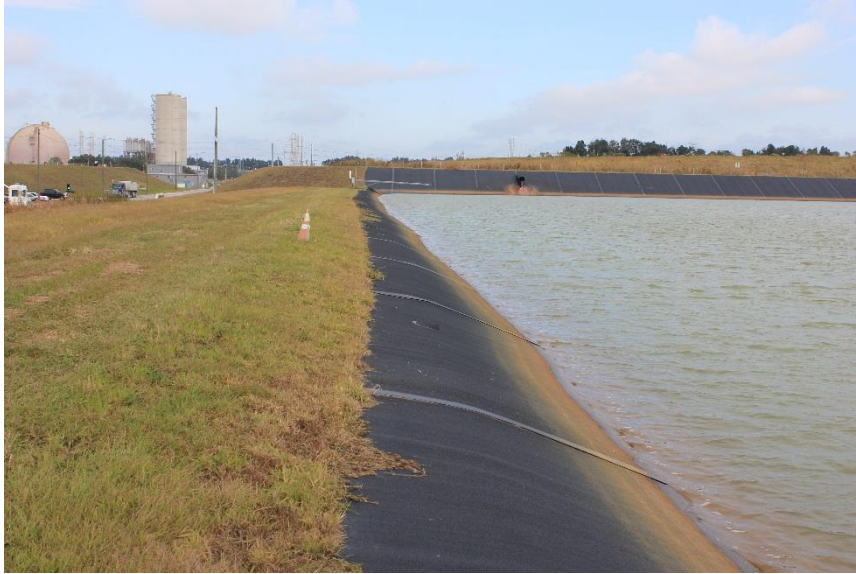
Long Term Fly Ash Pond
(west side, looking north)

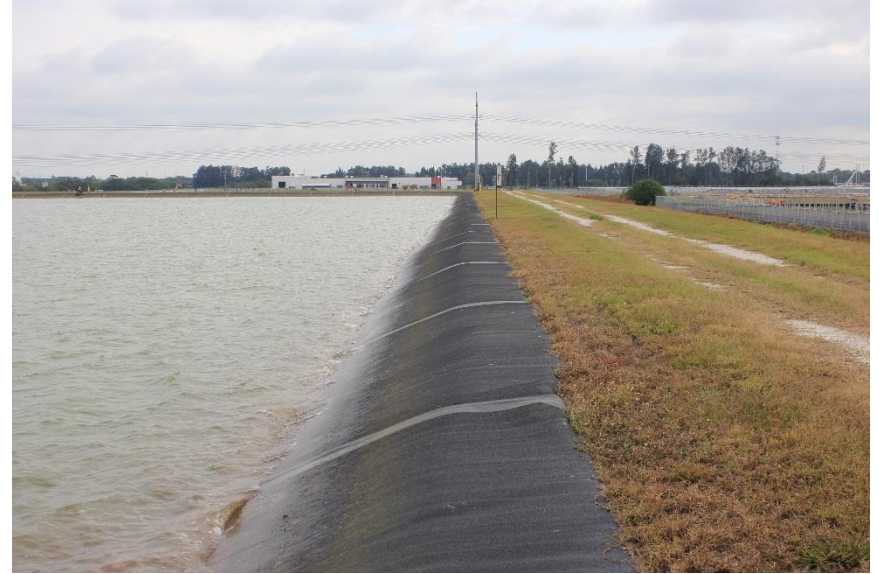
Long Term Fly Ash Pond
(south side, looking east)

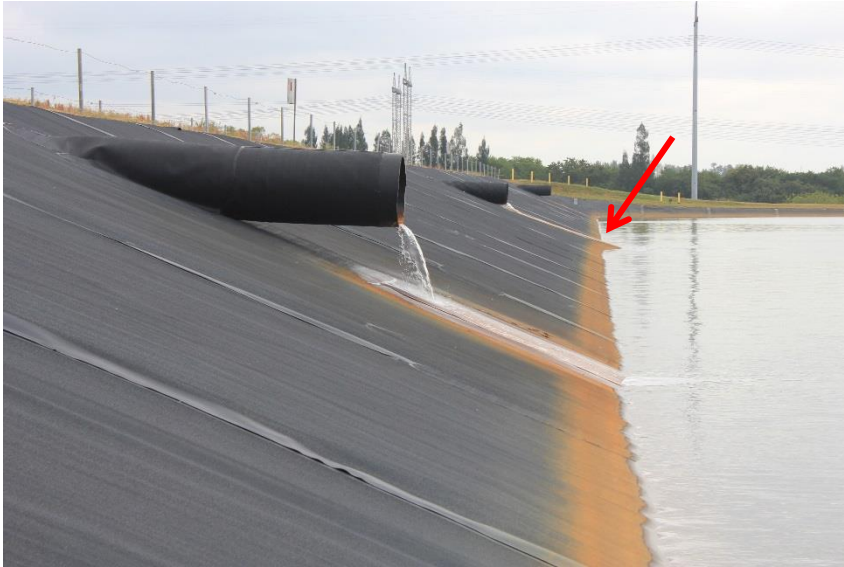
Long Term Fly Ash Pond - A small bulge was noted beneath the central pipe that drains storm water from the South Economizer Ash Pond to the Long Term Fly Ash Pond. The bulge in the liner below this pipe was first noticed during our March 19, 2014 Quarterly Inspection. The shape of the bulge has changed somewhat over time. The reason for the bulge is not readily apparent. Since the bulge is directly below a drainage pipe, we recommend that this area be further inspected. Small tears were also observed near the top of the slope at the north end of the east and west slopes.

Long Term Fly Ash Pond
(north side, looking east at bulge below central pipe
from South Economizer Pond)

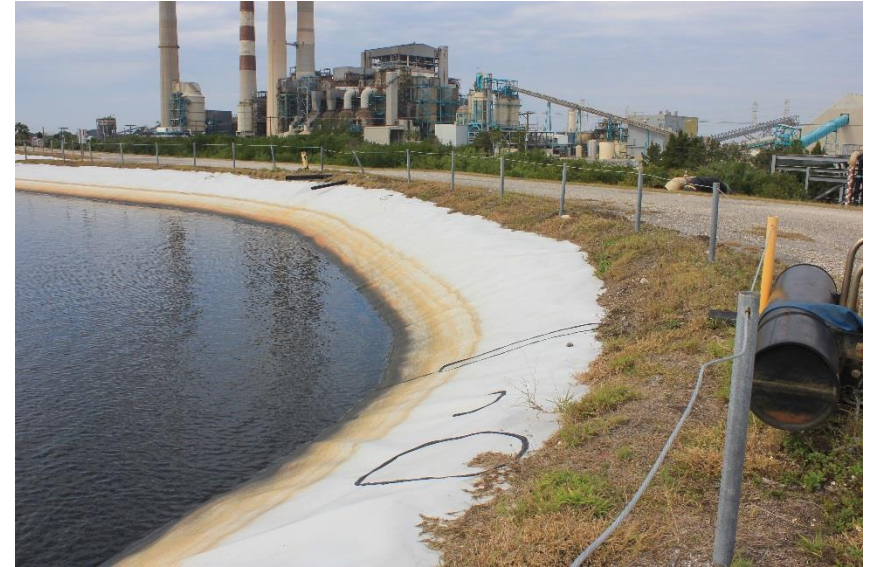
North Bottom Ash Pond
(north side, looking west)

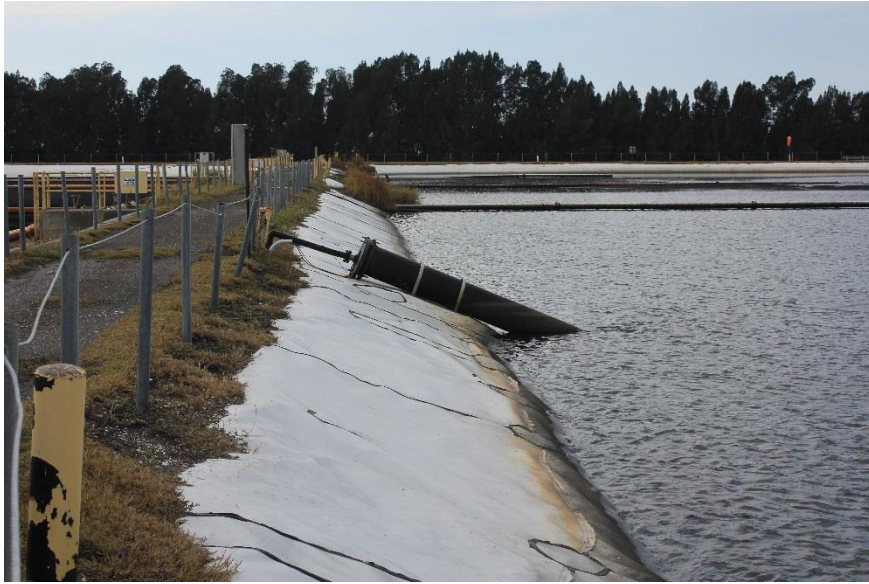
North Bottom Ash Pond
(south slope, looking west)

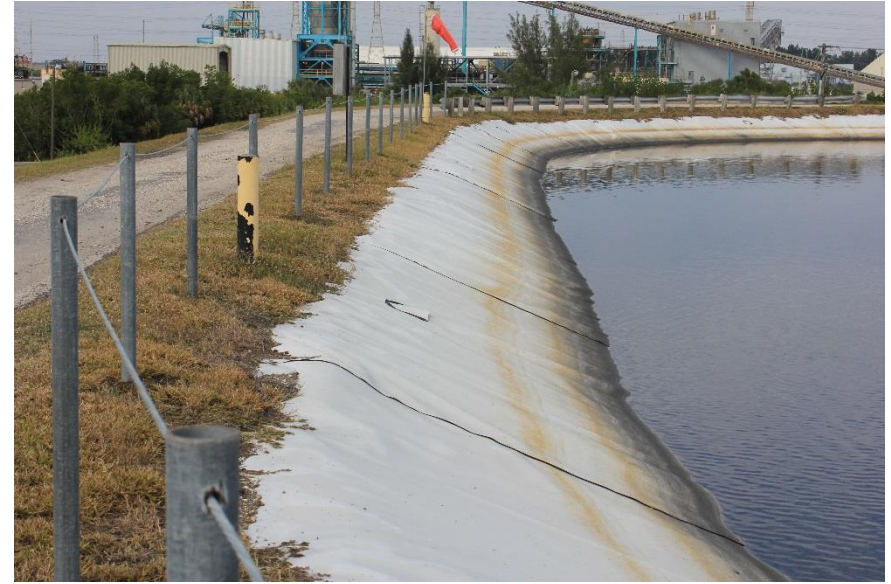
North Bottom Ash Pond
(west slope, looking north)

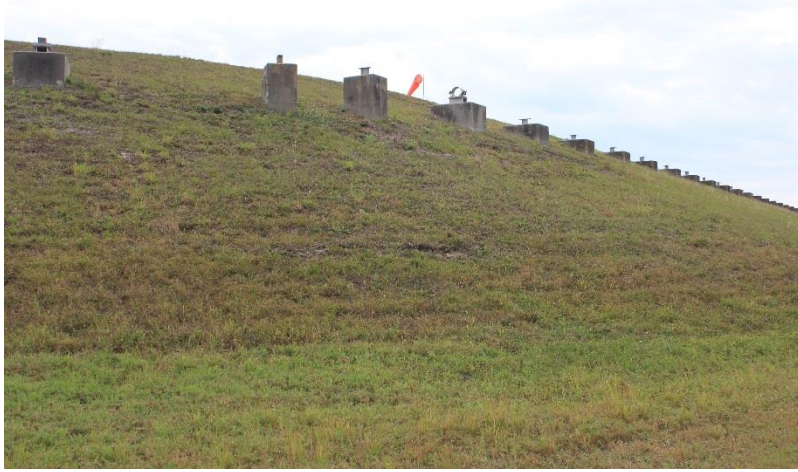
North Bottom Ash Pond
(west side, looking east)

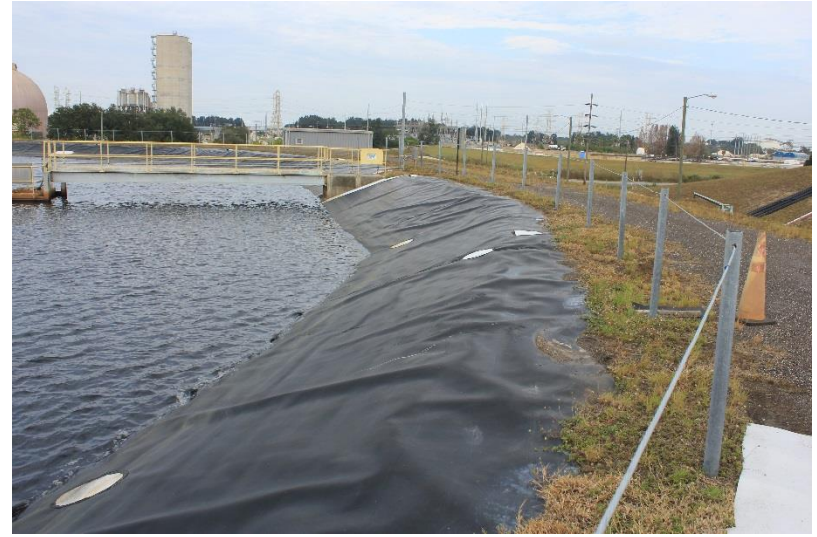
Bottom Ash Suction Pond
(east side, looking north)

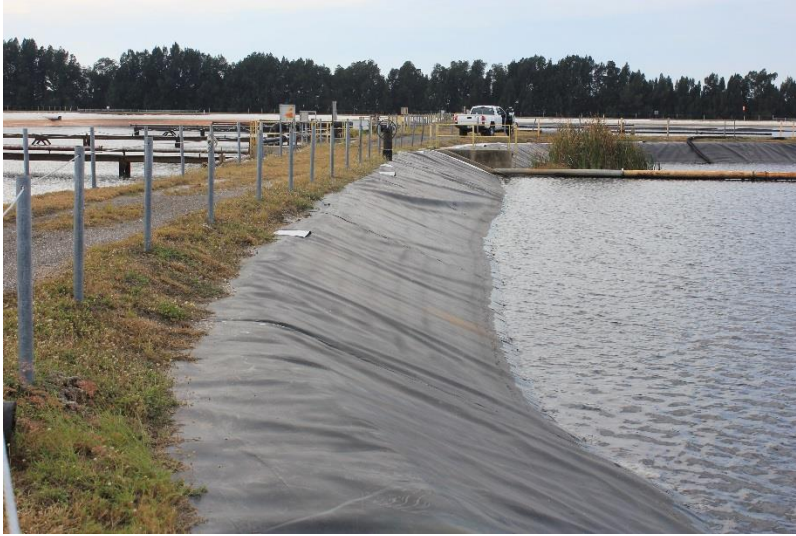
Bottom Ash Suction Pond
(south side, looking west)

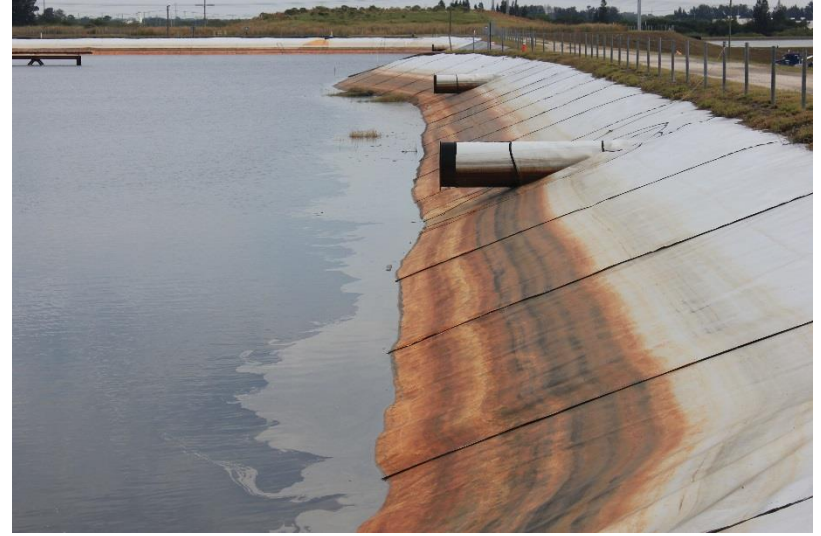
South Bottom Ash Pond
(south side, looking east)

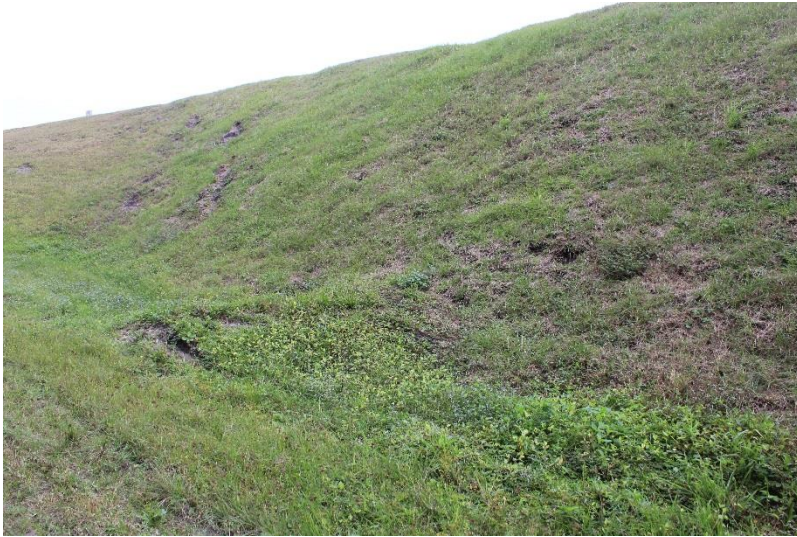
South Bottom Ash Pond
(west side, looking northeast)
Irregular rutting noted

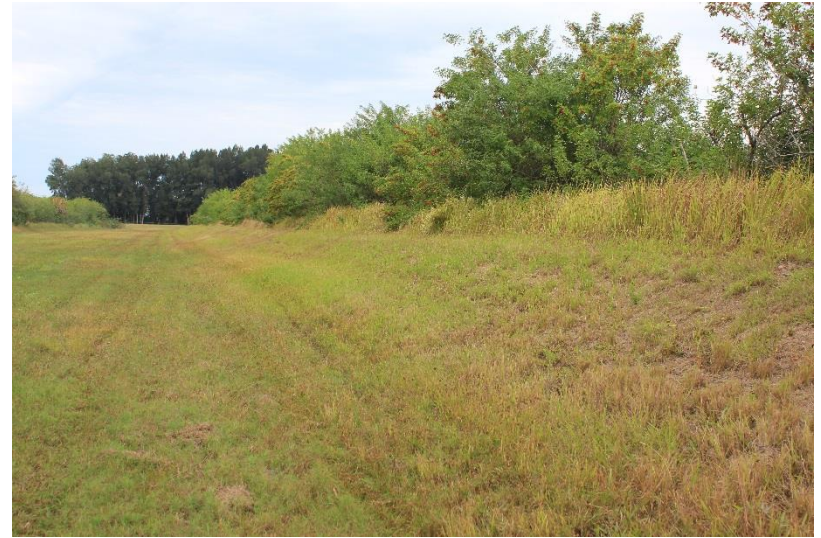
Long Term Bottom Ash Pond - An area designated “Long Term Bottom Ash Pond Area” is currently used occasionally for storm water overflow. This area is rimmed by low berms overgrown with vegetation which is not routinely cut / maintained. Therefore, the area cannot be inspected to the same detail as the other berms. No obvious breaches were noted during our observations of the readily accessible portions of the Long Term Bottom Ash Pond Area. Should this area be used for more permanent storage, we recommend that the east, south, and west berms be re-graded and filled to a uniform elevation, wide enough for vehicular traffic. The slopes should then be grassed. These improvements would facilitate future inspection and maintenance of these berms.

Long Term Bottom Ash Pond
(south side, looking west)
