Subject: **First Annual (2015) CCR Impoundment Inspection Report**
Economizer Ash Pond System – FDEP#20
Tampa Electric Company
Big Bend Power Station
Apollo Beach, FL
AREHNA Project No. B-15-073

Economizer System Earthen Berm Inspection
TECO Big Bend, FL
AREHNA Project No. B-15-073

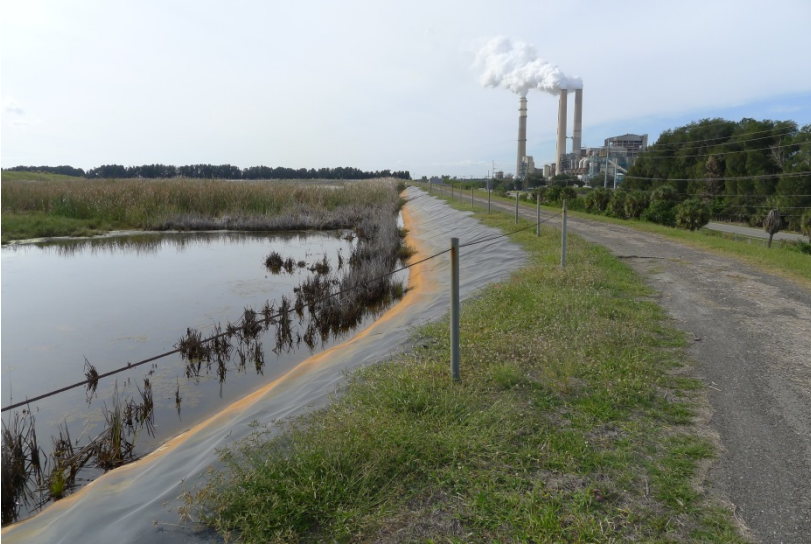
North Economizer Ash Pond
(north side, looking west)

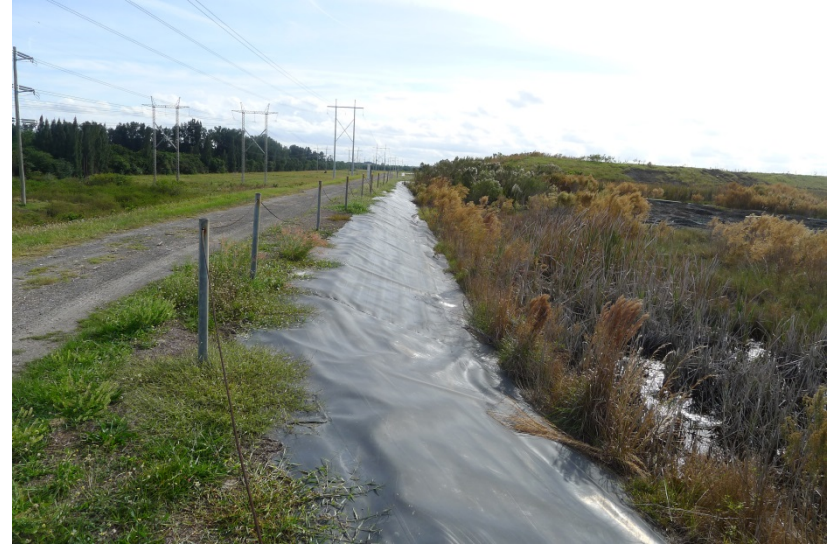
North Economizer Ash Pond
(east side, looking south)

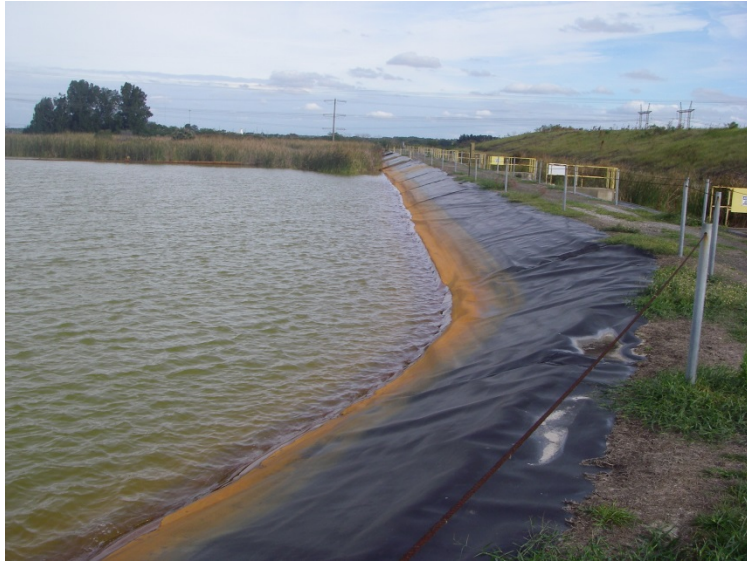
North Economizer Ash Pond
(south side, looking east)

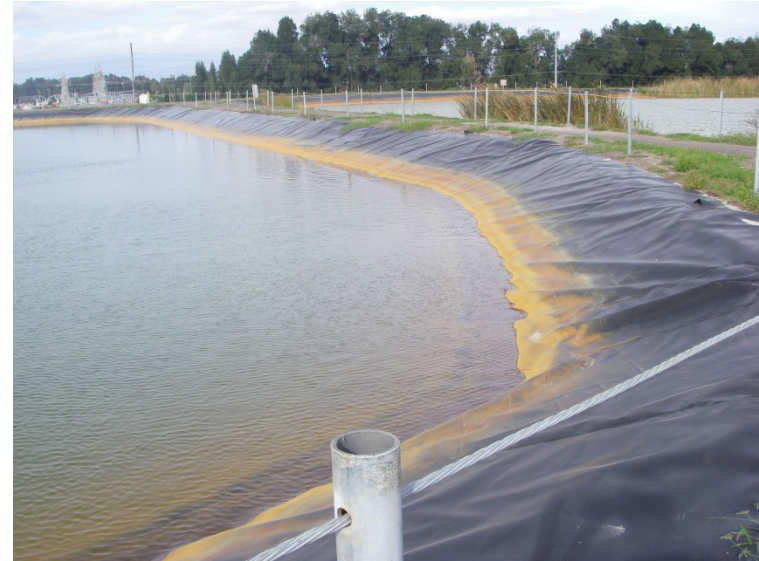
Economizer Ash Suction Pond
(east side, looking northeast)

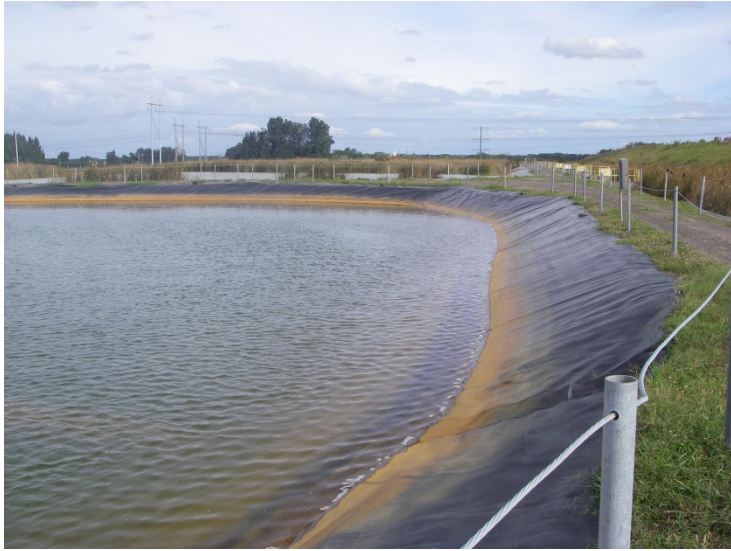
Economizer Ash Suction Pond
(south side, looking east)

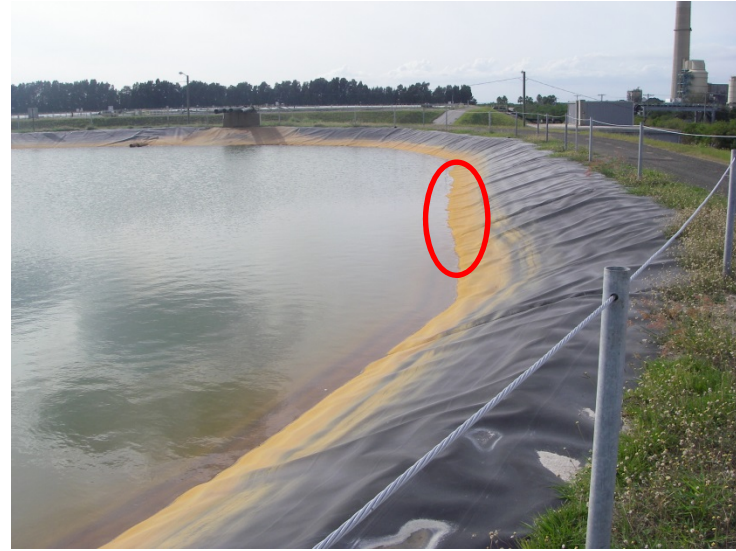
- There is a small bulge in the liner beneath the central pipe that drains stormwater from the previously capped and inactive South Economizer Ash Pond to the Long Term Fly Ash Pond. The reason for the bulge is not readily apparent. Since the bulge is directly below a drainage pipe, we recommend that this area be further inspected.
- The lined inside north-slope of the economizer ash suction pond has an inconsistent slope surface that also resembles a bulge. The water level in the suction pond should be lowered and this area further inspected.

Economizer Ash Suction Pond
(north side, looking west
at irregular liner surface)

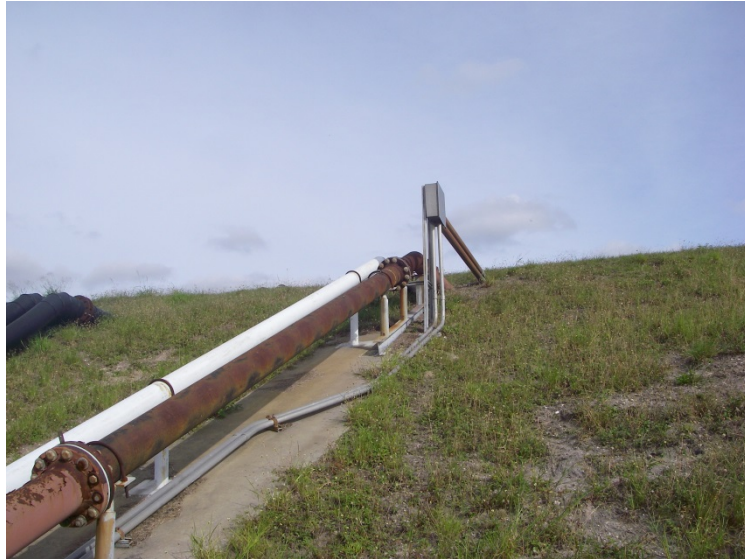
Economizer Ash Suction Pond
(west side, looking east
at embankment penetrations)

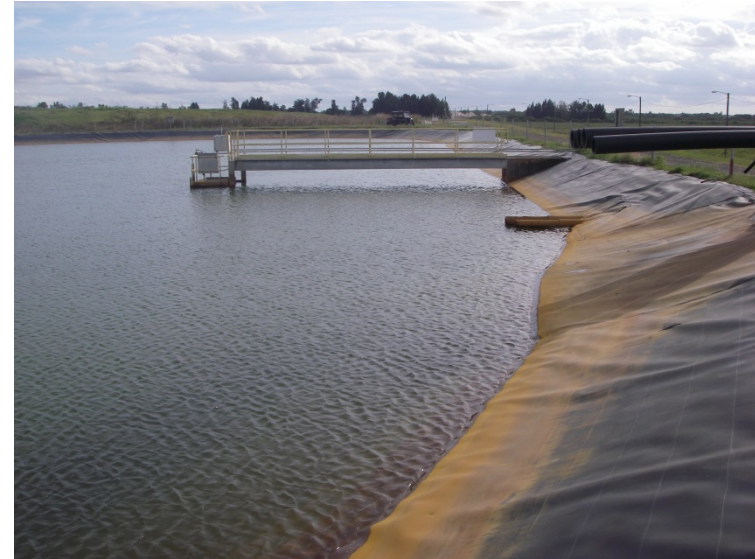
Economizer Ash Suction Pond
(west side, looking south
at instrumentation platform)

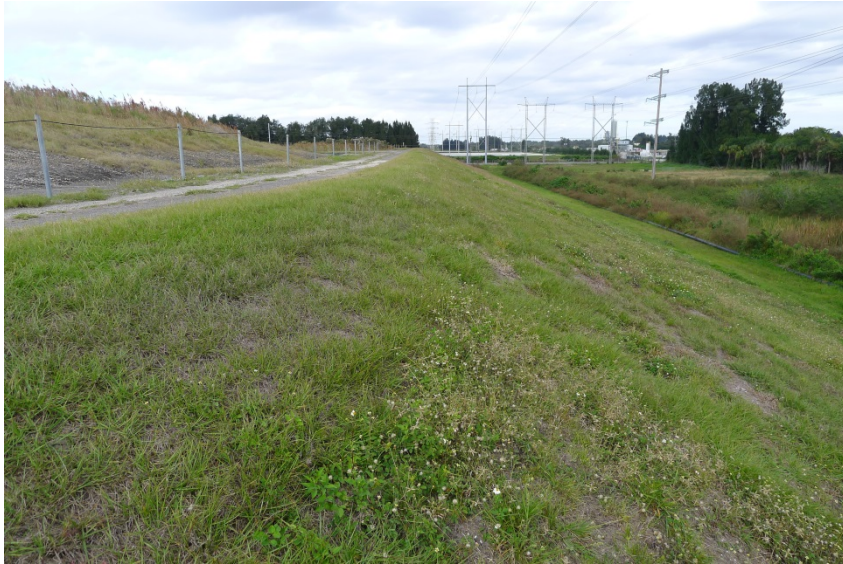
South Economizer Ash Pond
(east side, looking north)

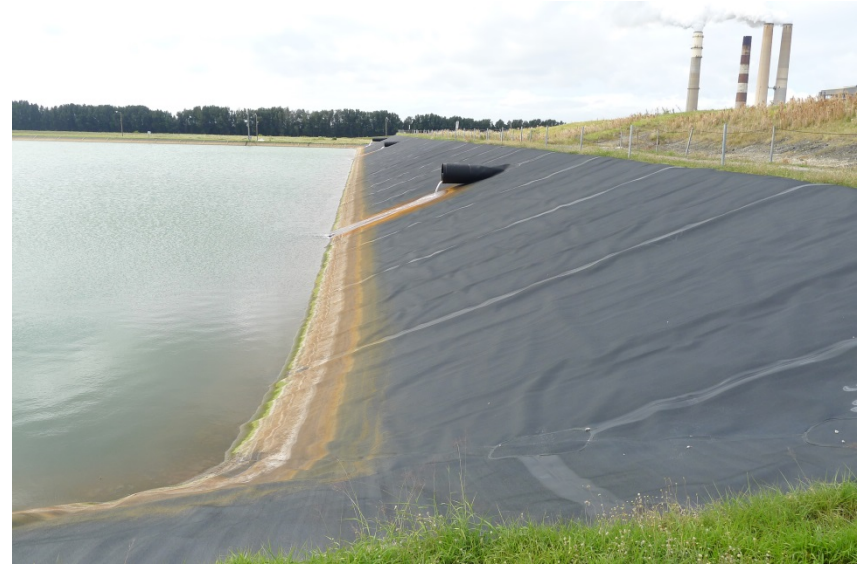
South Economizer Ash Pond
(south side, looking west)

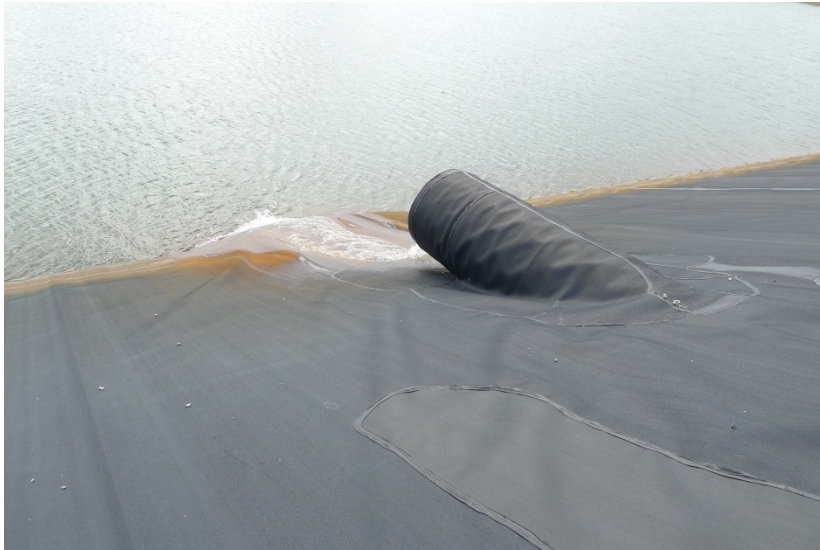
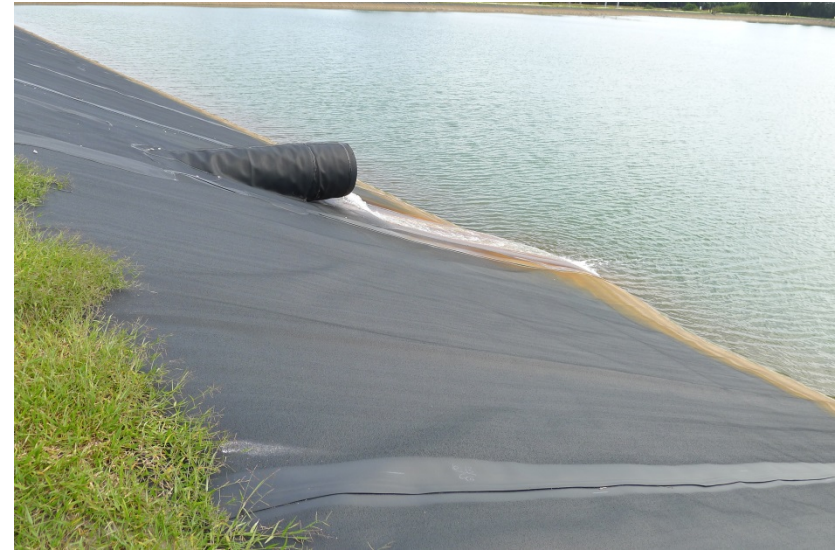
South Economizer Ash Pond
(south side, looking southwest
at bulge below central pipe discharging
into the Long Term Fly Ash Pond)

South Economizer Ash Pond
(south side, looking southeast
at bulge below central pipe discharging
into the Long Term Fly Ash Pond)

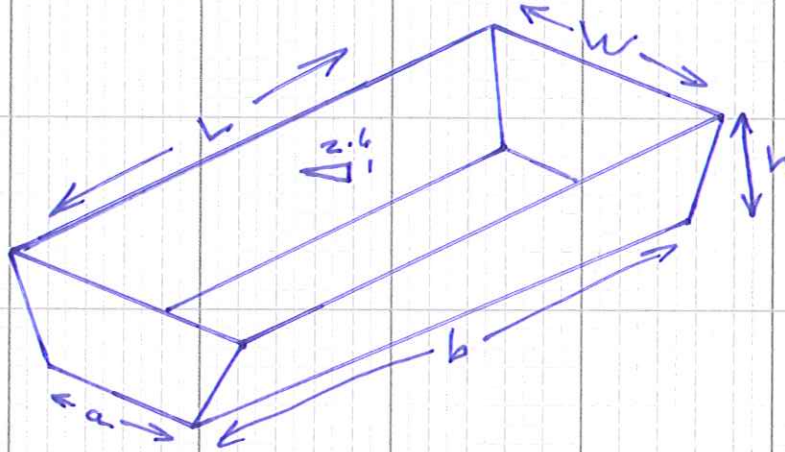
NORTH ECONOMIZER ASH POND

- TOP OF BANK/ELEV. = +31
- TOP OF WATER = +27.5'
- LINER ELEV. = +5'

• $V_{\text{Volume}} = h [ab + 0.5(W-a)b + 0.5(L-b)a + \frac{1}{3}(W-a)(L-b)]$
 $= 22.5 [195(575) + 0.5(312-195)575 + 0.5(692-575)195 + \frac{1}{3}(312-195)(692-575)]$
 $= \underline{\underline{3,638,992 \text{ ft}^3}}$ ✓ SAY: 83 ACRE FEET ✓
